# CASE STUDY - SILO INSTALLATION

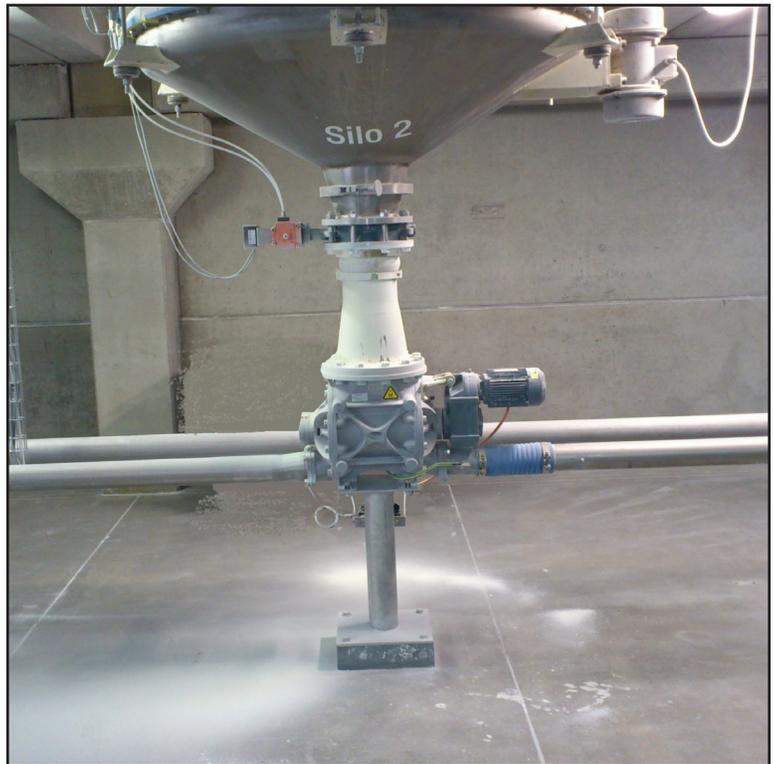
**BEFORE**

The upper connector is usually of a fairly large diameter, the lower connector is much smaller as it leads to the connecting pipes or rotary valves. Both of these connectors cause the usual problems experienced with flexible connectors. The large diameter connector is typically installed in difficult to reach places and because of the sheer size it is very time consuming to replace. Traditionally, this connector is either held in place with hose clamps around the outside of the connector or with an internal clamp system which means that the connector needs to be pulled through two sets of steel rings which are then fastened with screws all around the whole circumference of the connector.

The hose clamp has the usual disadvantages of product leakage and poor pressure resistance, the ring connector is a slight improvement but is even harder to replace because of the numerous screws and the difficult process of pulling the connector into the correct position. Both the upper and lower connectors are subject to the usual leaking from around the clamp and are particularly vulnerable to major hygiene issues of product being caught for long periods of time between the flanges and the connectors.

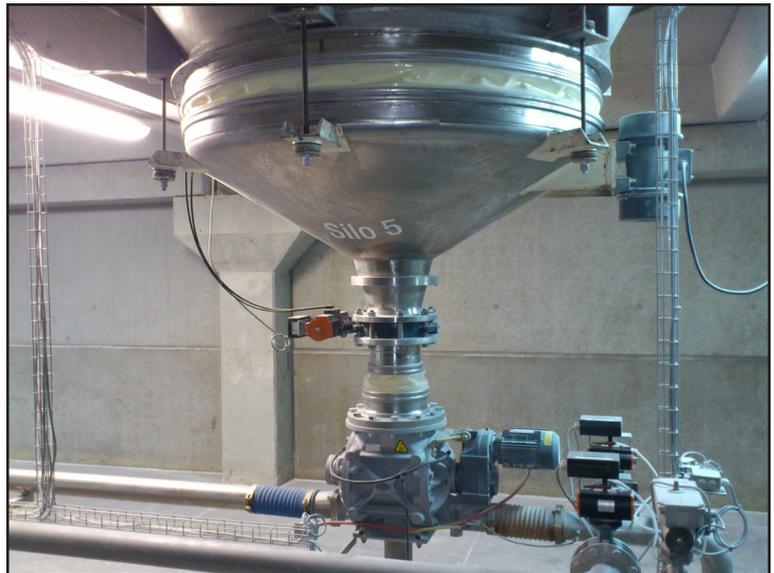
**AFTER**

**The end result** was two BFM® connectors now solved all four problems; difficult and time consuming installations, unhygienic environment and areas around the clamped connector, product leakage and insufficient pressure resistance. Whereas it previously took the operators up to two days to complete a replacement of the upper connector, this can now be done within 15

minutes max. The lower connector which was previously held in place with hose clamps is now completely dust tight and when using the correct connector material, will withstand even exceptional inside pressures. In the past the hose clamp connectors would flow off occasionally when the valve below was not working properly and inside pressure was exceeding the normal range. So the customer now has a safe, hygienic and easy to maintain piece of equipment!

**The BFM® solution.** In this particular case, the upper connector was a 1600 diameter and 100mm long. The lower connector was a 200 diameter with a length of 100mm. Below the lower connector was a tapered steel part enlarging the exit of the silo from 200mm to 250mm, which was the necessary diameter to connect the silo outlet to the rotary valve underneath. Quite often the vertical space is limited and the space requirement for BFM® connectors including the necessary spigots can be a problem. The solution was to remove the tapered steel part at the bottom and lower the complete activator down far enough to allow for the four spigots to be installed and still leave enough height for each connector. A tapered BFM® connector at the bottom solved the problem due to a difference in outlet and inlet diameter.
